**PROPERTY CONDITION ASSESSMENT
OF
WORLD TRADE CENTER PORTFOLIO**

FIVE WORLD TRADE CENTER

**Property #5
Merritt & Harris, Inc. Project Number 20-251E**

**Re: Due Diligence Physical Condition Survey
World Trade Center
New York, New York**

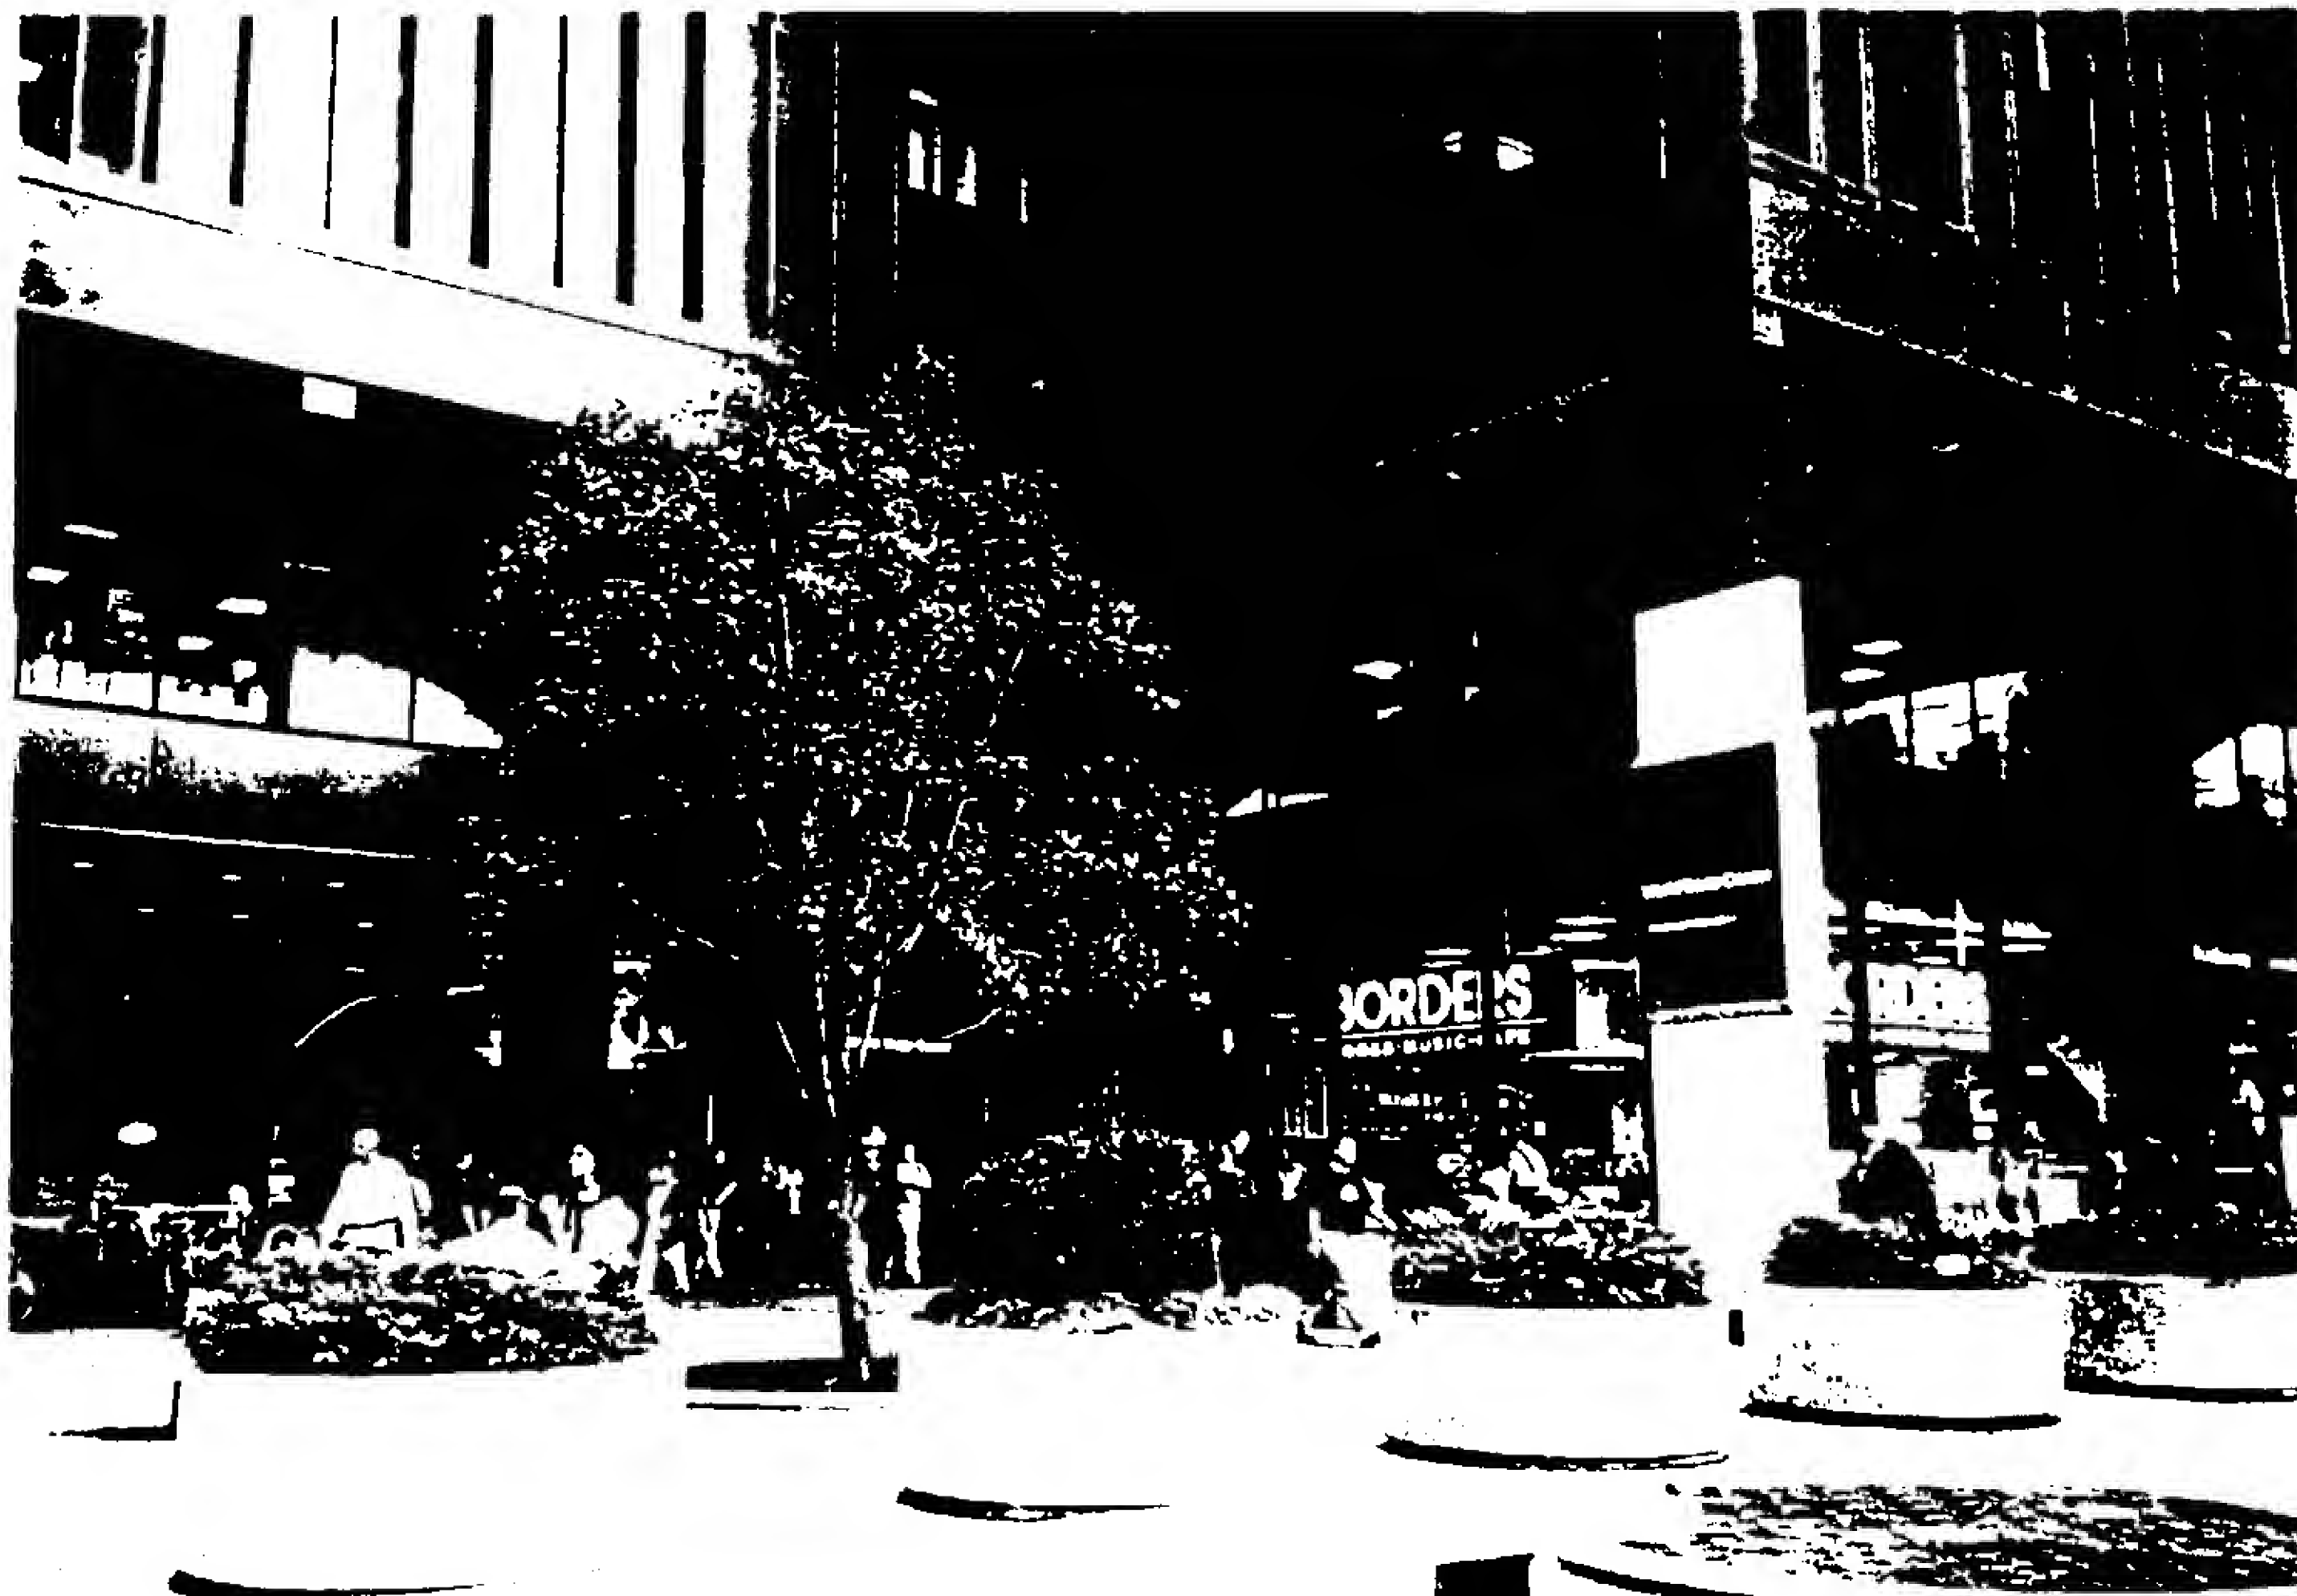
Photograph 1

**Entrance pylon
at Church Street
Plaza entry**

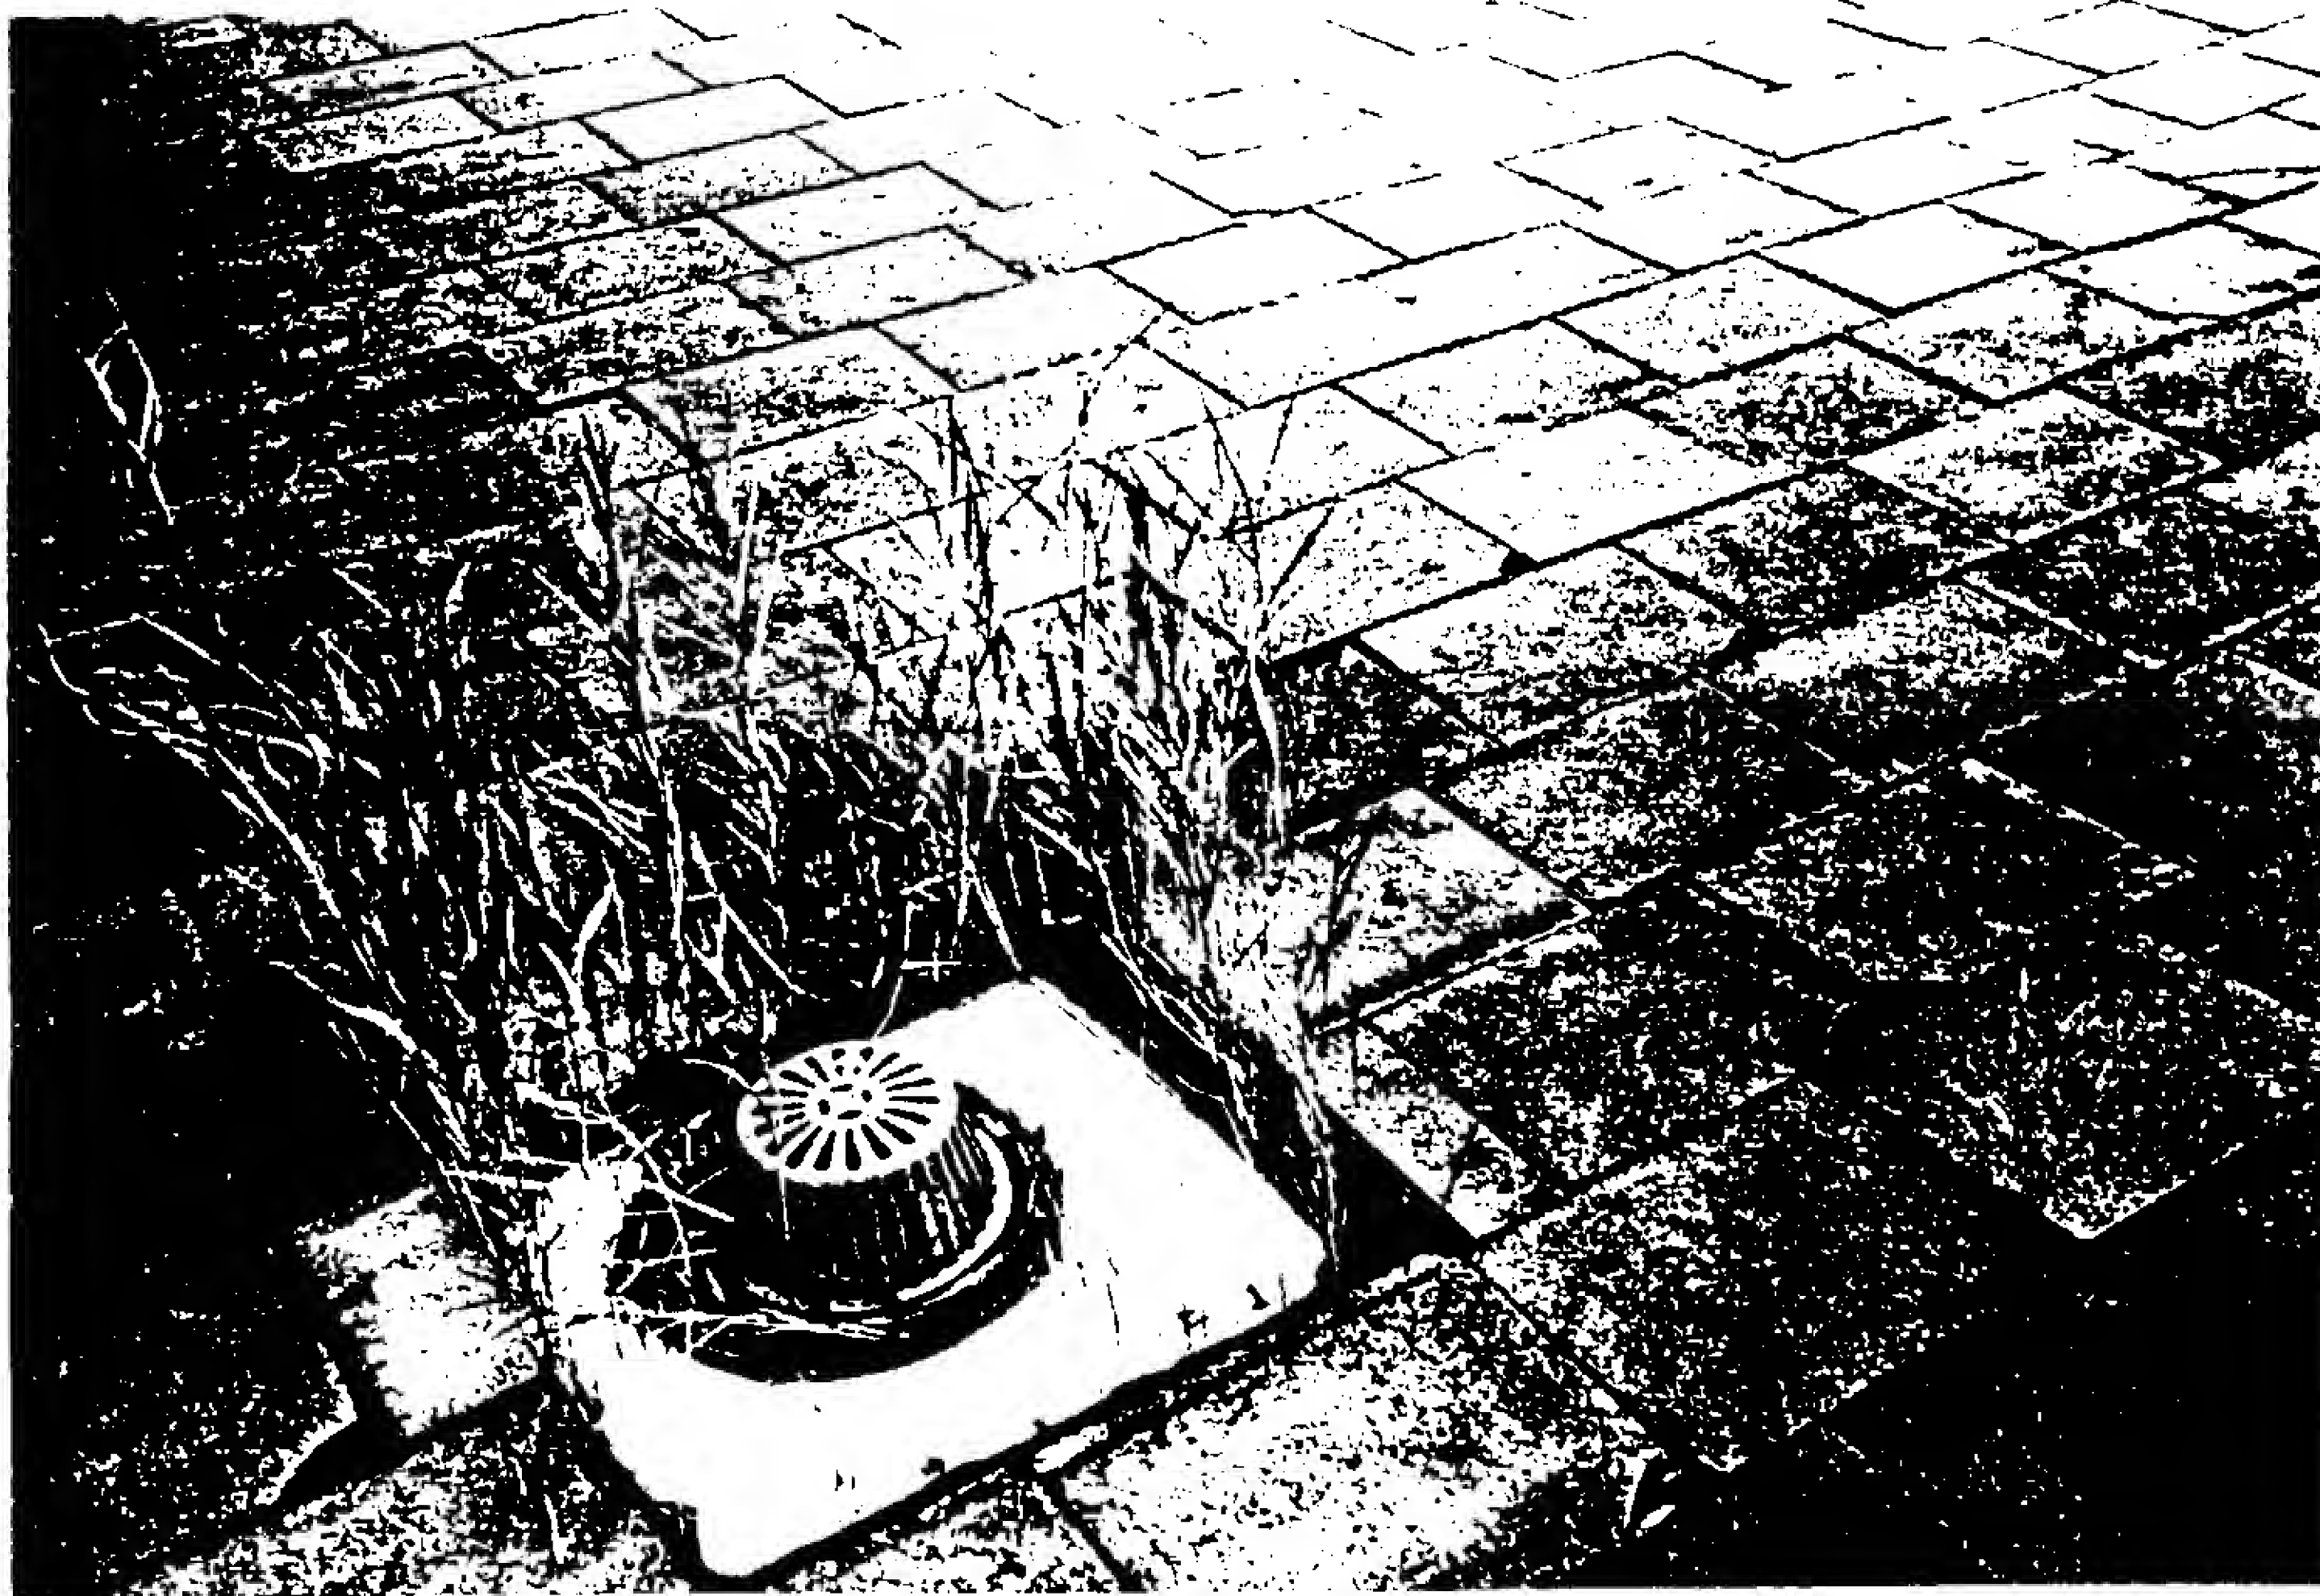
Photograph 13

Detail of roof
drain with
vegetation
growth
supported by the
moisture held in
paver backing

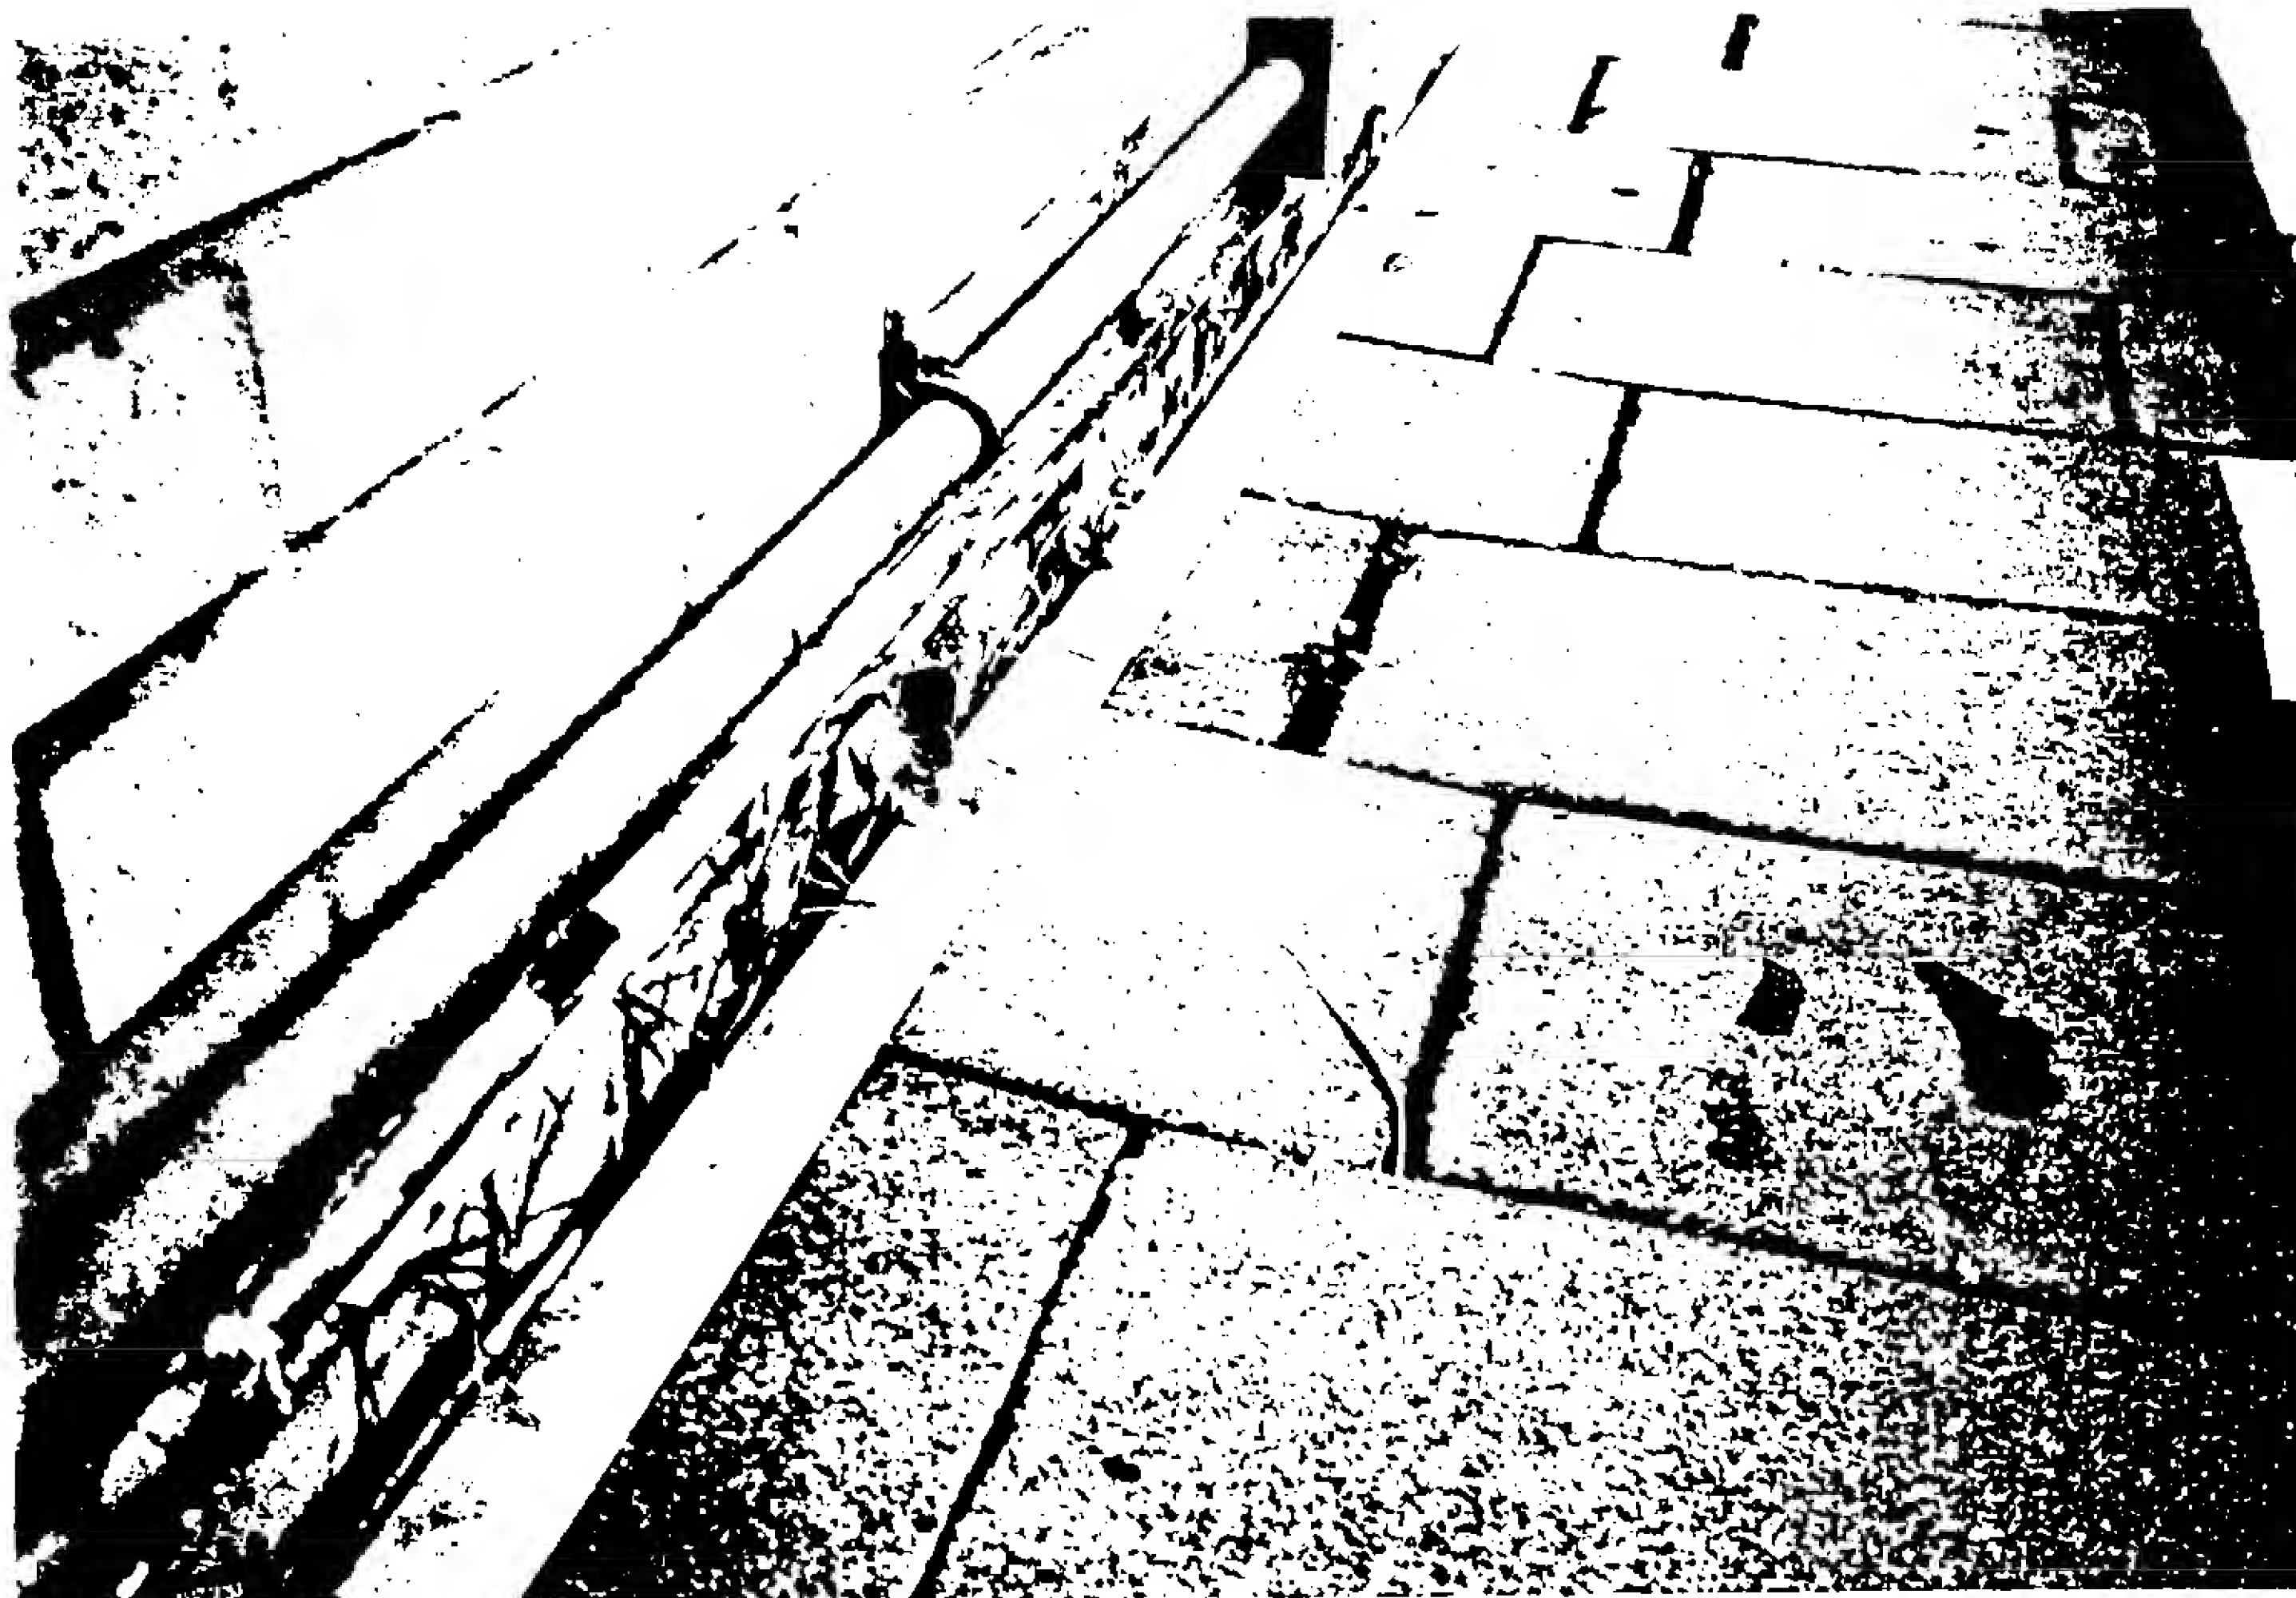
Photograph 14

Detail of
perimeter
flashing detail
with vegetation
growth

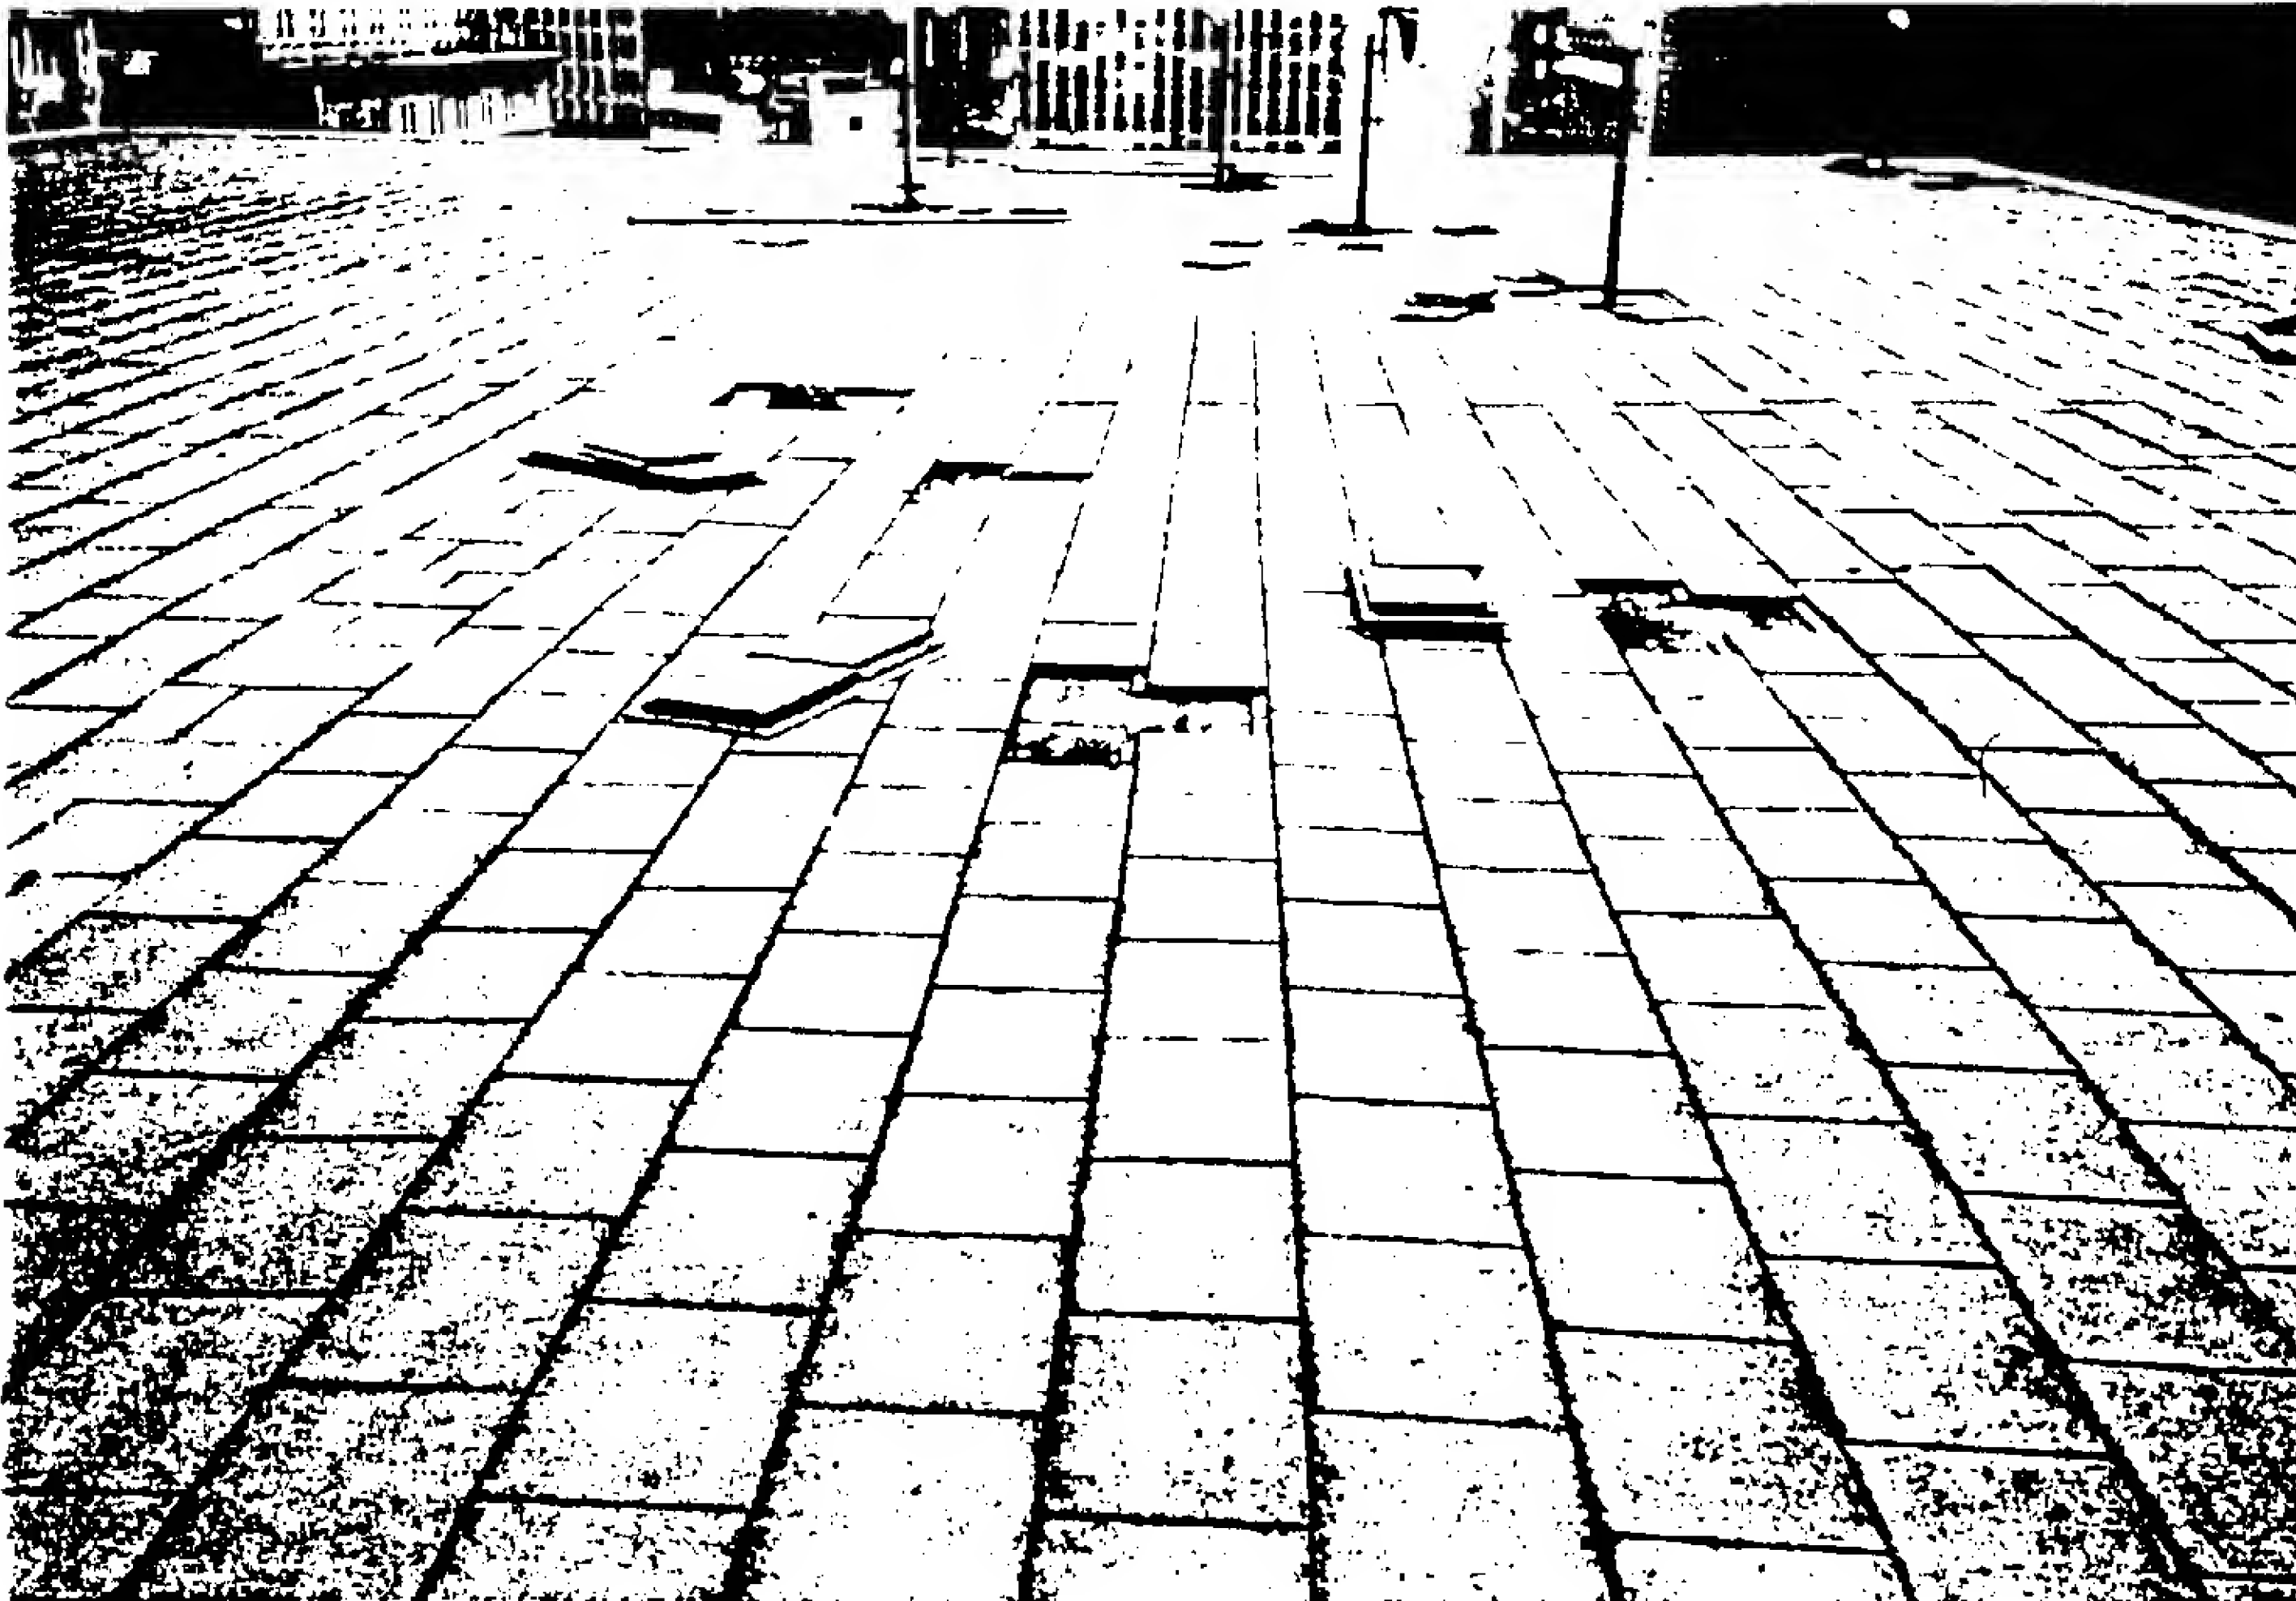
Photograph 15

**Penthouse roof
with pavers
removed for
patching of
membrane**
